# 9/16/2008 GAY DITCH FLUME

#### ASSESSMENT

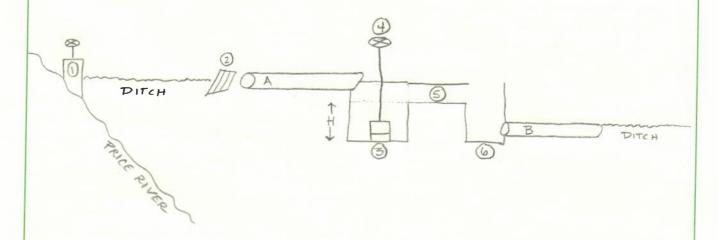
- 1) DIVERSION DAM AND HEADGATE OWNED BY CARBON COUNTY FREQUENTLY WASHES OUT BEAVER PROBLEMS
- 2 8" GRATE LEANED AGAINST PIPE SERVING AS TRASH RACK
- A 22" ID PIPE SLOPE = 0.001 ft/ft
- 3 CONCRETE SUMP
- 4 SLUICE GATE USED TO REGULATE FLOW
- H 201 "

- (5) 9" PARSHALL FLUME (ACTULLY 8 ")

~ 50 YEARS OLD

GAGE IS BOLTED INTO THE THROAT

SHOULD BE MOVED 4" TO READ @ 2/3 THROAT

METAL IS STARTING TO CORRODE
- 6 CONCRETE SUMP DRAINED BY 14" ID PIPE
- B 14" ID PIPE

- FLUME MEASURED FLOW 28% LOWER THAN WE MEASURED USING THE HARSH MCBIRNEY CURRENT METER.
- " WE WOULD LIKE THE ACCURACY IMPROVED BEFORE WE INSTALL THE AUTOMATED METER AND TELEMETRY.
- FOUR IMPROVEMENTS IDENTIFIED:
  - I. RAISE THE FLOOR OF SUMP 3 UP TO THE FLOOR OF THE FLUME, THIS SHOULD REDUCE TURBULENCE IN THE FLUME.
  - 2. SLOW THE FLOW THROUGH PIPE A. POSSIBLY INLET FLOW COULD BE RESTRICTED THROUGH A SUBMERGED ORIFACE.
    ALTERNATIVELY BAFFLES COULD BE INSTALLED IN PIPE A.
  - 3. PLACE AUTOMATED MONITORING IN CORRECT LOCATION IN THROAT.
    ADD GAGE THERE FOR MANUAL MONITORING.
  - 4. ADD WING WALLS TO THE FLUME, TURBULENCE IN THE SUMP CORNERS SHOULD BE REDUCED.
